[Docket No. 99–SW–11–AD; Amendment 39–11113; AD 99–08–07]

Airworthiness Directives; McDonnell Douglas Helicopter Systems (MDHS) Model 369E, 369FF, 500N, and 600N Helicopters

AD 99-08-07 McDonnell Douglas

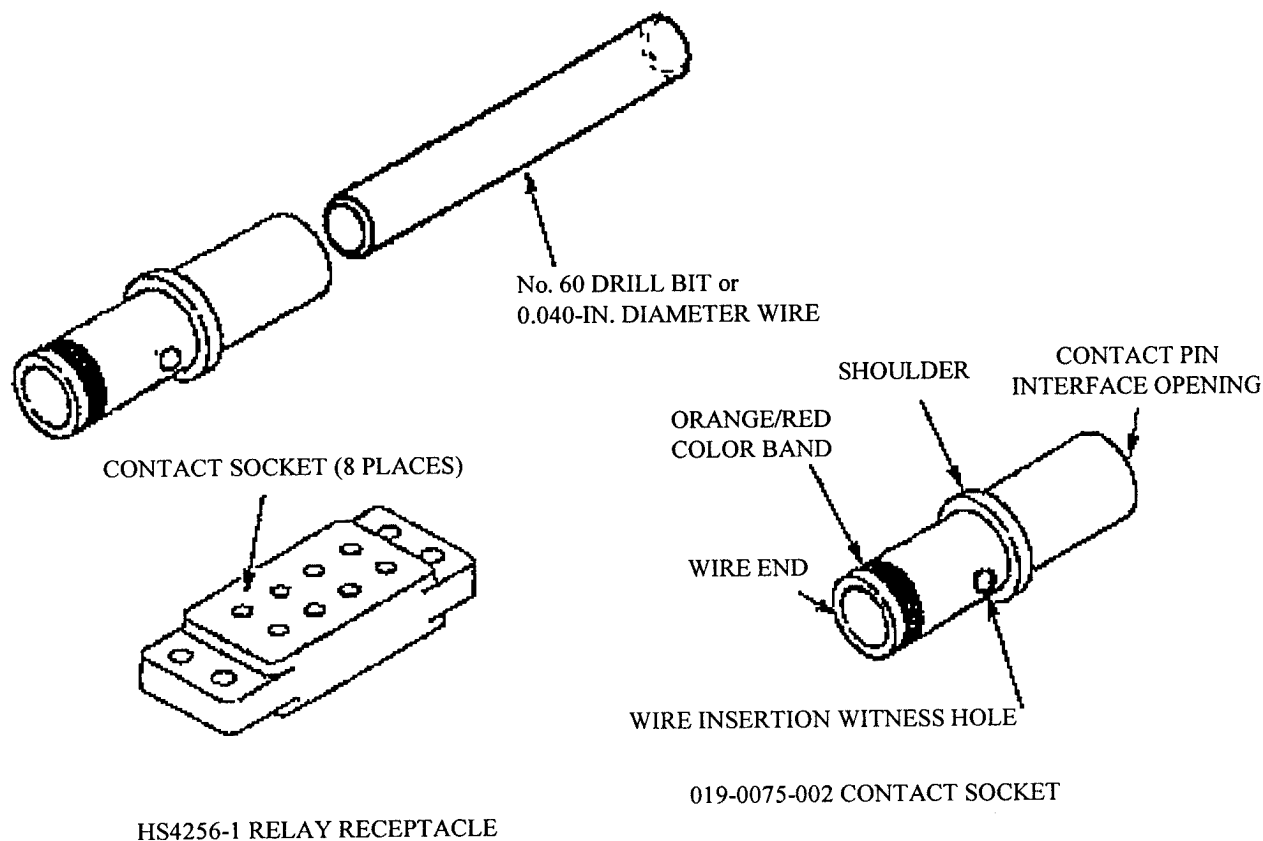
Figure 1. Contact Socket Inspection

Since the issuance of that AD, the FAA has determined that not all of the previously affected MDHS Model 600N helicopters have the unsafe condition; the prefix "RN" for the serial number for the MDHS Model 500N helicopters is incorrect; and the part number for the relay receptacle was incorrectly stated in Figure 1.

(c) Using a No. 60 drill bit or a 0.040-in. diameter wire as a gauge, attempt to insert the gauge into every contact socket (socket) of each relay. Ensure the gauge is inserted perpendicular to the face of the receptacle, to prevent damage to the receptacle and the socket (Figure 1). If the gauge can be inserted into a socket, it is unairworthy and must be replaced with an airworthy socket, P/N 019-0075-002.

(d) Any replacement relay, P/N HS4240, must be inspected prior to further flight, in accordance with paragraph (c) of this AD.
