[Docket No. 2000-NM-136-AD; Amendment 39-11962; AD 2000-22-15]

Airworthiness Directives; Boeing Model 747-100, -200B, -200C, -200F, and -300 Series Airplanes Delivered In or Modified Into the Stretched Upper Deck Configuration

2000-22-15 Boeing: Amendment 39-11962. Docket 2000-NM-136-AD.

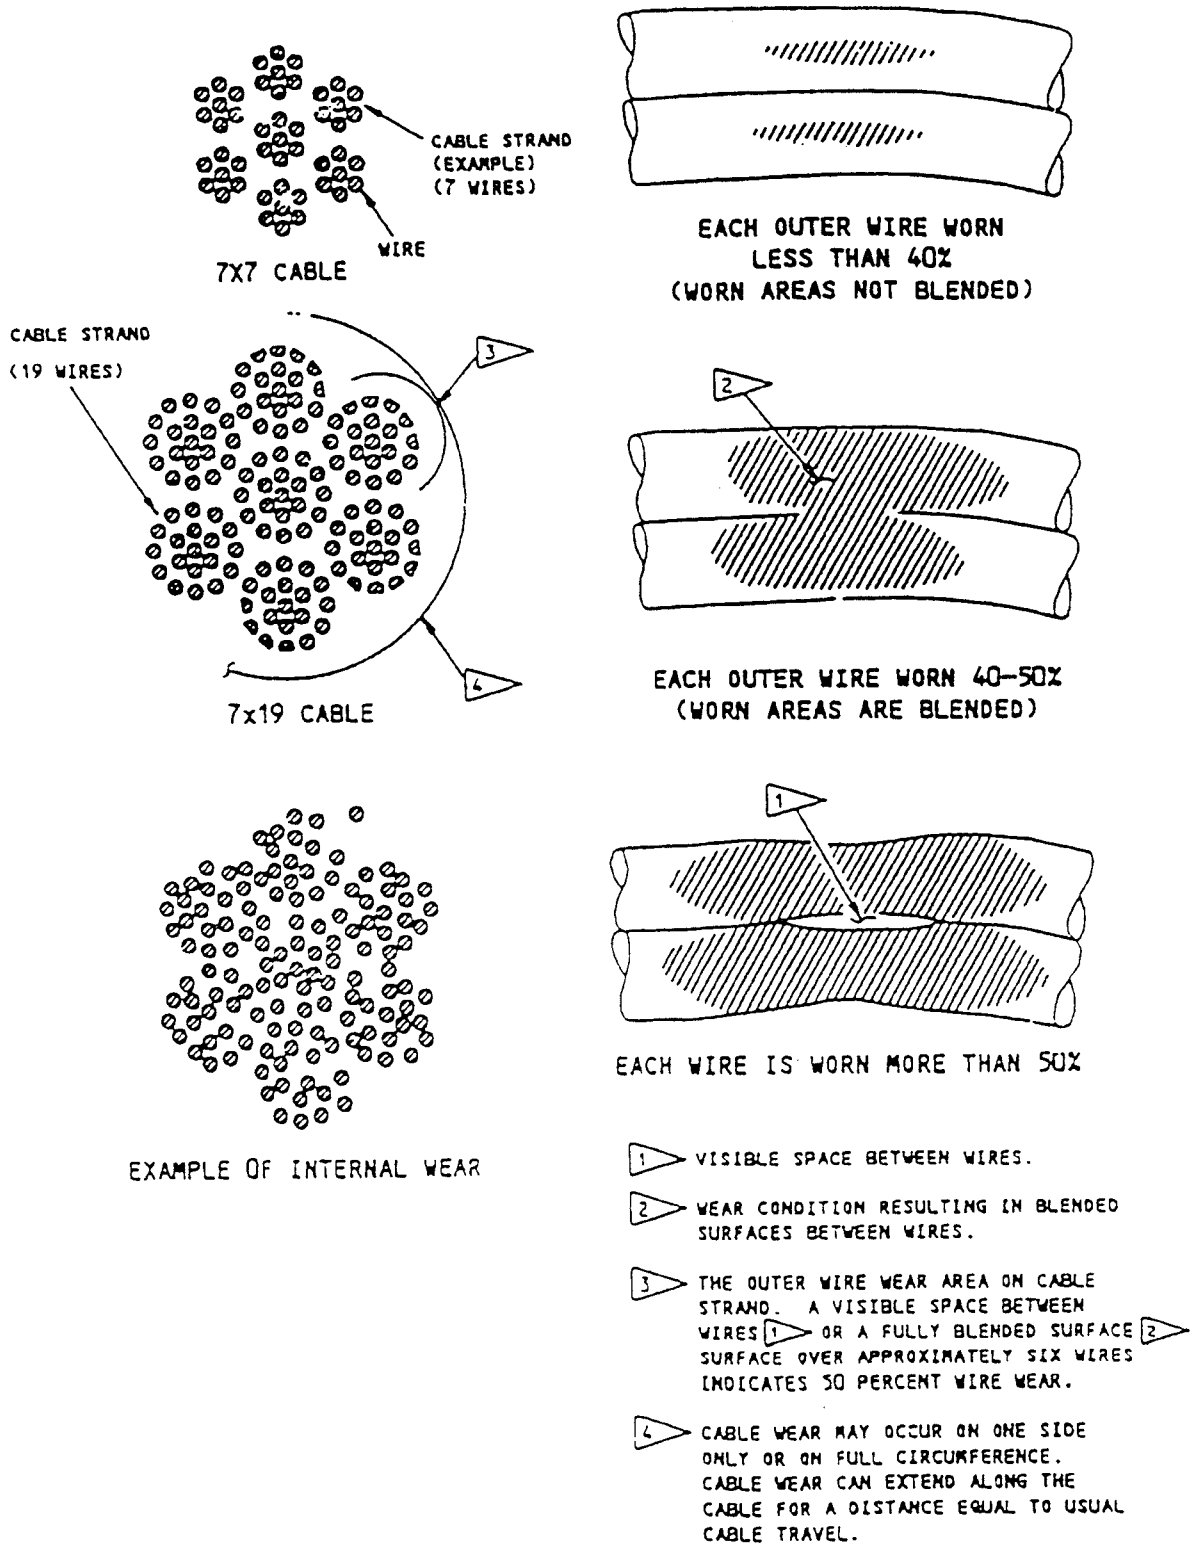
FIGURE 1

- A. Perform a detailed visual inspection of the engine thrust control cables in the area of the plate to detect wear.
- B. Replace the cable assembly if any of the following criteria are met:
- (1) One cable strand had worn wires where one wire cross section is decreased by more than 40 percent (see Figure 1).
 - (2) A kink is found.
 - (3) Corrosion is found.

(2) Perform a detailed visual inspection of the engine thrust control cables in the area of the plate to detect wear and broken wires in accordance with Appendix 1 (including Figure 1) of this AD. If any wear is within the criteria contained in Appendix 1 (including Figure 1) of this AD, no further action is required by this paragraph. If any wear outside the criteria contained in Appendix 1 (including Figure 1) of this AD is found, prior to further flight, replace the cable with a new cable, in accordance with the procedures described in the Boeing 747 Maintenance Manual.
