**DEPARTMENT OF TRANSPORTATION**

[Docket No. 2000-SW-51-AD; Amendment 39-11960; AD 2000-20-51]

**Airworthiness Directives; Robinson Helicopter Company Model R22 Helicopters**

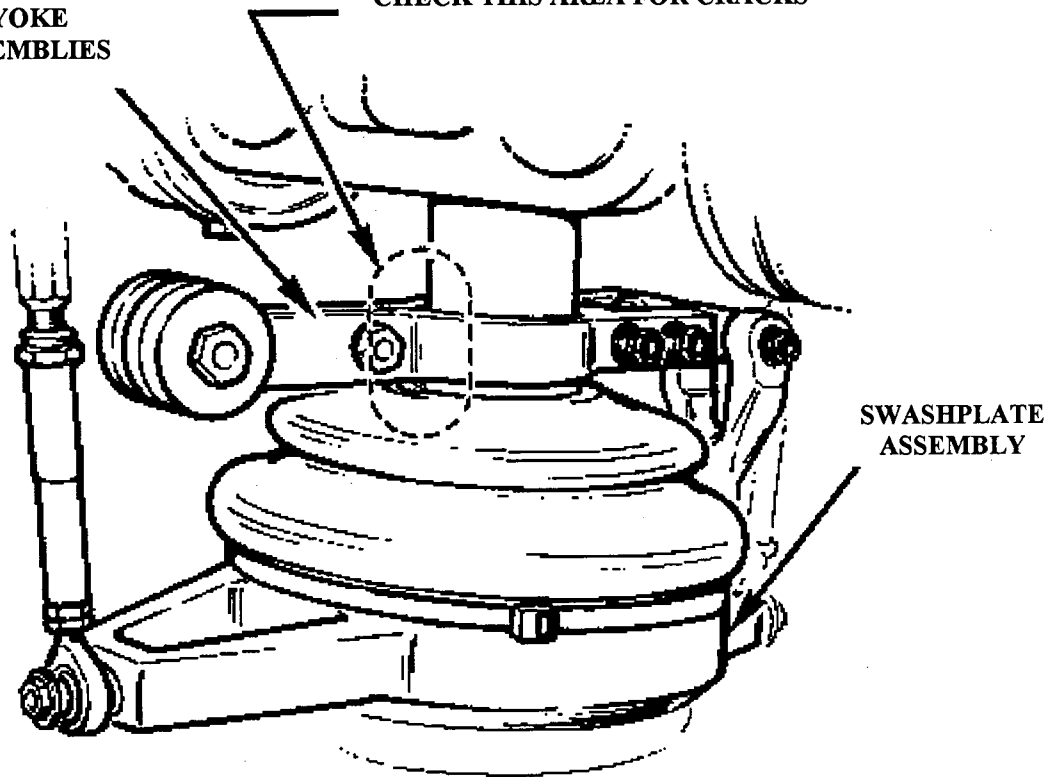
**Figure A**

yoke half assembly (yoke) for any crack and replacing a cracked yoke assembly before further flight. This AD also requires replacing certain yokes with airworthy yokes before further flight after January 1, 2001. This AD is prompted by the discovery of cracks in the yoke. The actions specified by this AD are intended to detect crack formation and growth, which could result in separation of the yokes from the main rotor drive shaft and subsequent loss of control of the helicopter.

**SUPPLEMENTARY INFORMATION:** On October 4, 2000, the FAA issued Emergency AD 2000-20-51, for RHC Model R22 helicopters, which requires checking the yoke for any crack and replacing a cracked yoke assembly before further flight. The Emergency AD also requires replacing certain yokes with airworthy yokes before further flight after January 1, 2001. That action was prompted by the discovery of cracks in the yokes. The cracked yokes were still in service and functioned for an unknown duration. Several lots of the yokes were machined from 2024-T3 aluminum billet, which has poor stress corrosion properties in the transverse grain directions. Clamping the yokes in place causes a preload tension in areas that have exposed transverse grain. When these areas are exposed to a corrosive environment, such as salty air, stress corrosion causes crack formation and growth. This condition, if not

(a) Before further flight and thereafter before the first flight of each day, check each yoke for a crack. See Figure A.

**A203-5 YOKE  
HALF ASSEMBLIES**

**CHECK THIS AREA FOR CRACKS**

(b) If a yoke is cracked, before further flight, replace the yokes with airworthy yokes, P/N A203-7. Both yokes must be replaced with yokes, P/N A203-7.

(2) If the Lot identifier is from 24 through 43, if it is a letter code, or if it is illegible, replace yokes, P/N A203-5, with airworthy yokes, P/N A203-7. Yoke, P/N A203-7, cannot be installed with yoke, P/N A203-5.
