[Docket No. 99–SW–80–AD; Amendment 39–12983; AD 2002–25–07]

**Airworthiness Directives; Bell Helicopter Textron Canada Limited Model 206L, L–1, L–3, and L–4 Helicopters**

#### 2002–25–07 Bell Helicopter Textron

**Canada Limited:** Amendment 39–12983. Docket No. 99–SW–80–AD. Supersedes AD 99–13–12, Amendment 39–11207, Docket No. 99–SW–23–AD.

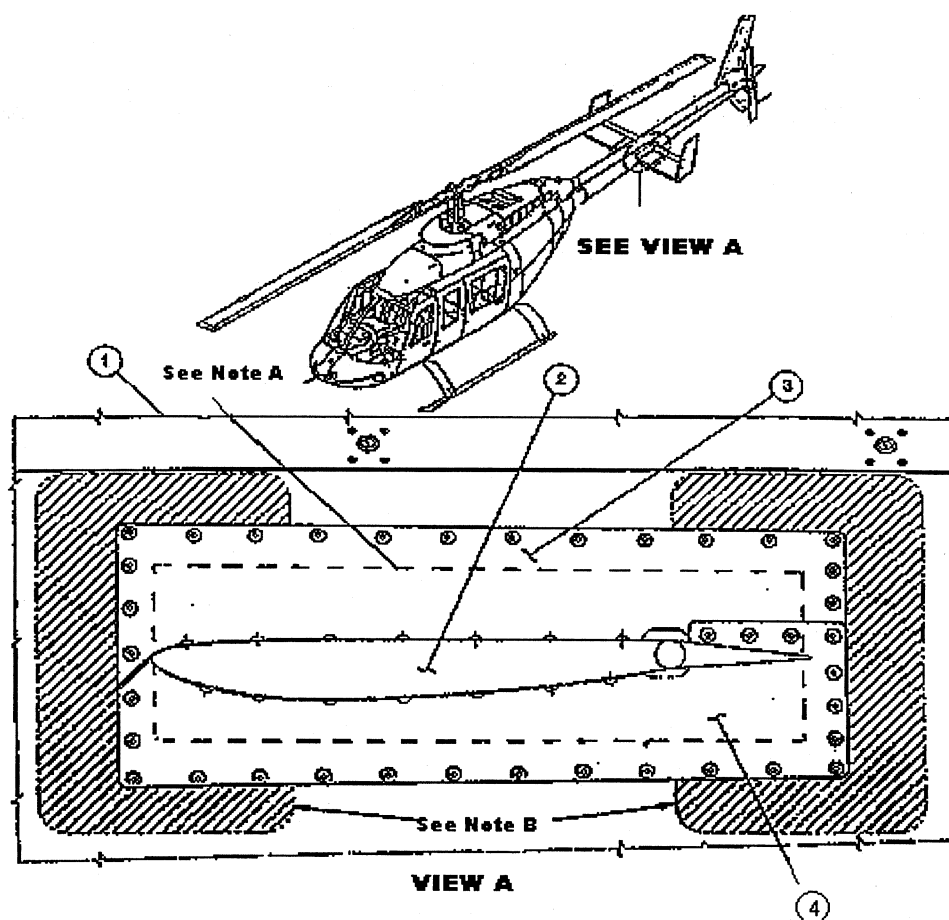
**Figure 1****BILLING CODE 4910-13-C**

(a) Before further flight and thereafter at intervals not to exceed 10 hours time-in-service (TIS) until accomplishing a one-time fluorescent-penetrant inspection (FPI) required by paragraph (c)(2) of this AD, visually inspect for a crack in the tailboom using a 10-power or higher magnifying glass in the shaded areas as depicted in Figure 1 of this AD:

- A. Inspect entire edge of stabilizer opening on both sides of the tailboom.
- B. Inspect for a crack in these two areas on both sides of the tailboom

(b) At intervals not to exceed 5 hours TIS, visually check for a crack in the tailboom in the shaded areas as depicted in Figure 1 of this AD. The visual check may be performed by an owner/operator (pilot) holding at least a private pilot certificate and must be entered

(2) Perform a one-time FPI of the edges of the tailboom skins for any crack around the left and right horizontal stabilizer openings as shown in Figure 1 of this AD. Remove paint and primer to inspect the edges and

exterior skin surface in the skin area at least  $\frac{3}{4}$  inch around the edges of the horizontal stabilizer openings as shown in Figure 1 of this AD.

(2) Visually inspect the entire edge of the horizontal stabilizer opening on both sides of the tailboom for any crack using a 10-power or higher magnifying glass as shown in Figure 1 of this AD.

(g) If a crack is found during any check or inspection required by this AD, before further flight, replace the cracked tailboom with an airworthy tailboom modified according to the requirements of paragraph (e) of this AD or with an airworthy tailboom, P/N 206-033-004-181.
