DEPARTMENT OF TRANSPORTATION

[Docket No. 2003–SW–26–AD; Amendment 39–13198; AD 2003–12–13]

Airworthiness Directives; Agusta S.p.A. Model A109K2 Helicopters

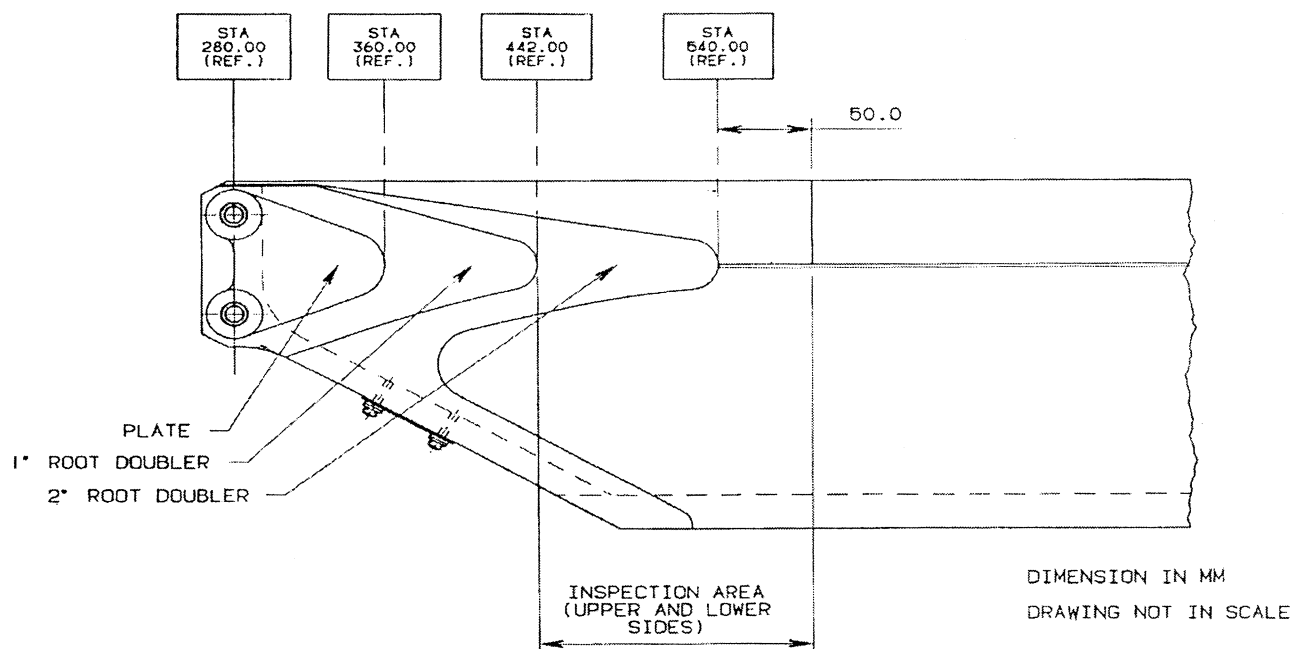
FIGURE 1

(a) Before each start of the helicopter engines, visually check the upper and lower surfaces of each blade for a crack in the area depicted in Figure 1 of this AD. An owner/operator (pilot) holding at least a private pilot certificate may perform this check, but must enter compliance with this paragraph into the aircraft records in accordance with 14 CFR sections 43.11 and 91.417(a)(2)(v). See Figure 1:

Note 1: Paint irregularities on the blade may be due to a crack.

(b) Before the first flight of each day, and thereafter at intervals not to exceed 5 hours TIS, and anytime an increase in vibration levels occurs, inspect each blade for a crack using a 5x or higher magnifying glass in accordance with Part II of the Compliance Instructions of Alert Bollettino Tecnico No.

(c) After each visual inspection using a 5x or higher magnifying glass and before further flight, if you are unable to determine by the visual inspection whether there is a crack, inspect each blade for a crack using a dye-penetrant method in accordance with Part II of the Compliance Instructions of the ABT and Figure 1 of this AD.

(d) If a crack is found, replace each cracked blade with an airworthy blade before further flight.
