[Docket No. FAA–2013–0725; Directorate Identifier 98–CE–01–AD; Amendment 39–17690; AD 98–15–18 R1]

Airworthiness Directives; Maule Aerospace Technology, Inc. Airplanes

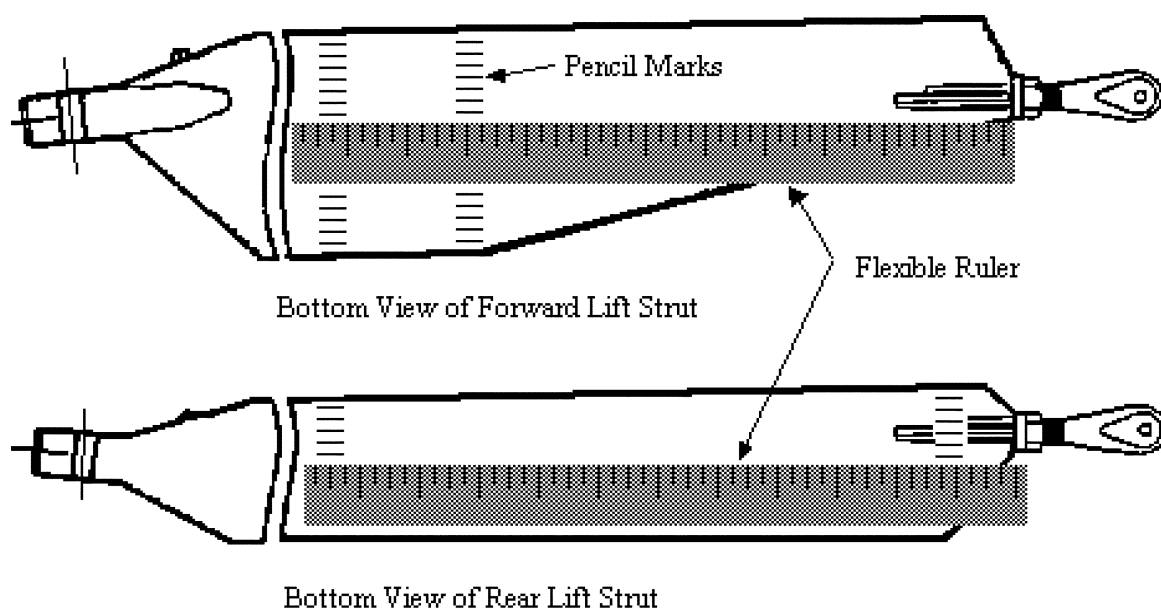
Figure 1

8. A measurement of 0.024 inch or less shall require replacement of the strut prior to further flight.

9. If at any time during testing an area is encountered where a valid thickness measurement cannot be obtained due to a loss of signal strength or quality, the area shall be considered suspect. These areas may have a remaining wall thickness of less than 0.020-inch, which is below the range of this setup, or they may have small areas of localized corrosion or pitting present. The latter case will result in a reduction in signal strength due to the sound being scattered from the rough surface and may result in a signal that includes echoes from the pits as well as the backwall. The suspect area(s) shall be tested with a Maule "Fabric Tester" as specified in Maule Air, Inc. Service Bulletin No. 11, dated October 30, 1995.
