Federal Register

Thursday, October 14, 1999

#### Airworthiness Directives; Eurocopter France Model SA-365C, C1, C2, N, and N1; AS-365N2; and SA-366G1 Helicopters

##### **AD 99-21-24 Eurocopter France:**

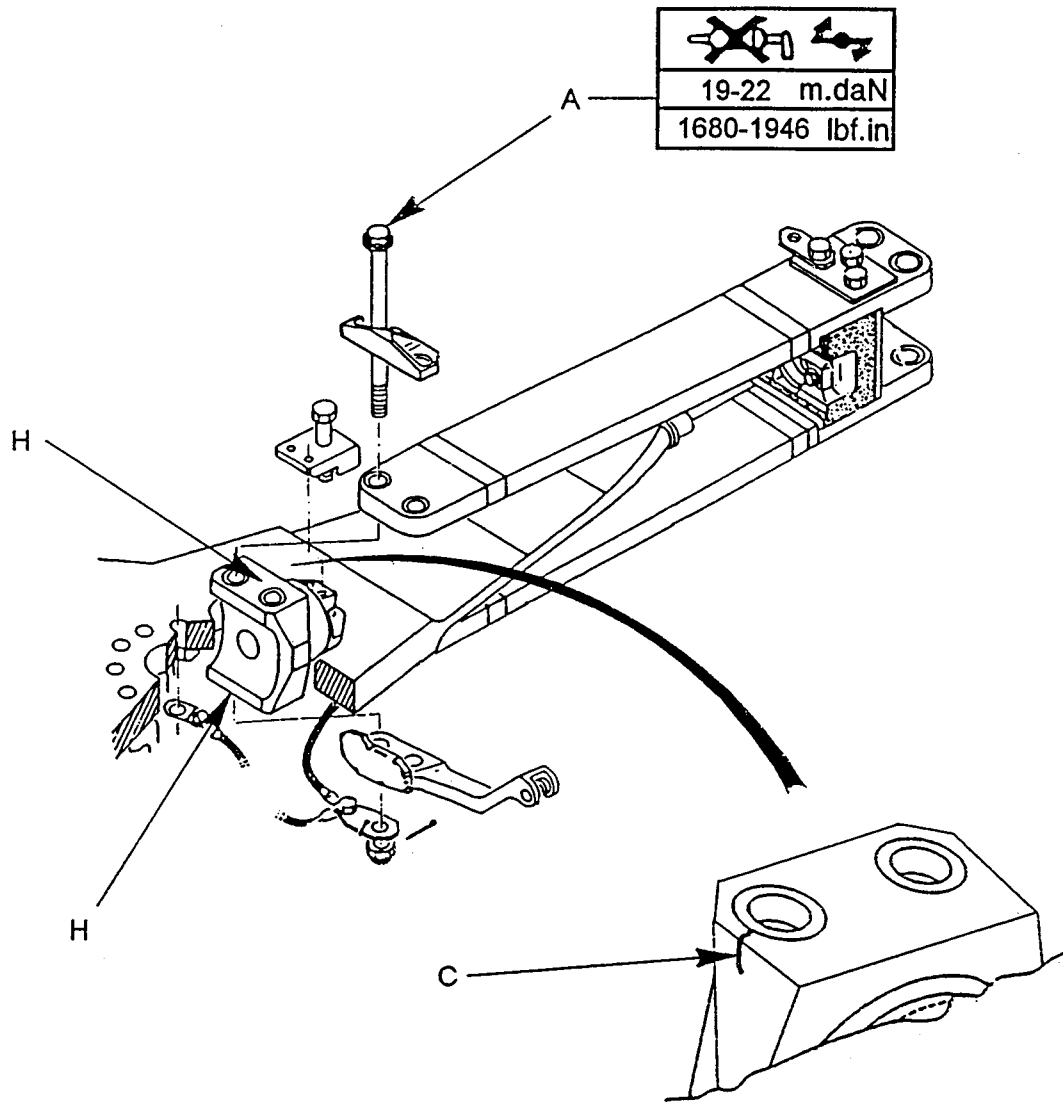
Figure 1

To prevent loosening of the main rotor hub blade attach beam spherical thrust bearing bolts (bolts), cracks in the metal components, failure of a spherical thrust bearing (bearing), and subsequent loss of control of the helicopter, accomplish the following:

(a) Inspect the tightening torque of the bolts as indicated by "A" in Figure 1.

(1) If tightening torque is equal to or less than 12 m.daN (88.4 lb-ft), remove the bearing and conduct a dye penetrant inspection for cracks on the two contact surfaces identified as "H" in Figure 1.

(i) If a crack is detected, replace the bearing with an airworthy bearing.

(ii) If no crack is detected, reinstall the bearing.

(2) If the tightening torque is greater than 12 m.daN (88.4 lb-ft), then tighten to 19-22 m.daN (140-162.2 lb-ft).
