49 CFR Part 571

Federal Motor Vehicle Safety Standards; Roof Crush Resistance

ACTION: Final rule.

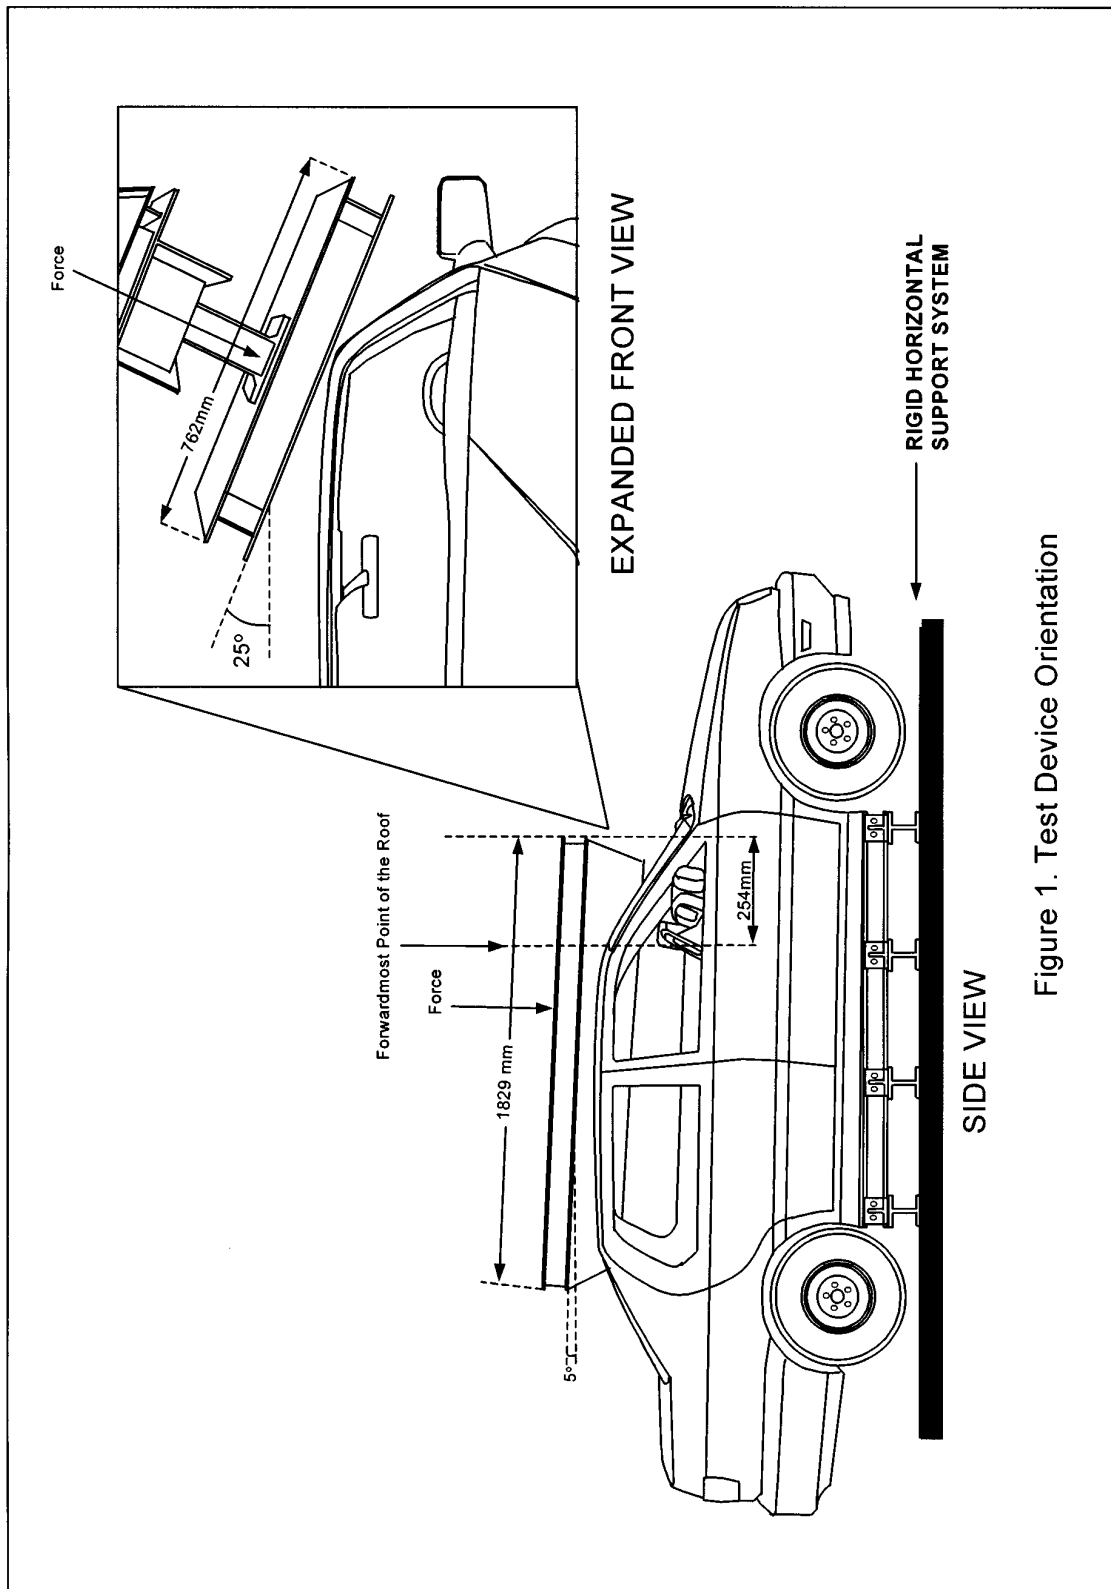
Figure 1 to §571.216

S7.2 Orient the test device as shown in Figure 1 of this section, so that—

Figure 1. Test Device Orientation

Ford believes that the test procedures as applied to some vehicles are contradictory. S6.2 of the standard says to "[o]rient the test device as shown in Figure 1 * * *", which shows the test plate in contact with the front corner of the roof, inclined longitudinally at an angle of 5 degrees. At the same time, S6.2(d) of the rule specifies that the initial contact point be 254 mm (10 inches) from the front edge of the test plate. Since the initial contact point will not be located at the front corner of the roof for certain vehicles with rounded roofs, there is a conflict between the specifications in S6.2(d) and Figure 1 in the regulatory text.

Paragraph S7.2 has been rewritten to clarify, but not change, the process of orienting the test plate and lowering so that it makes initial contact with the vehicle being tested. In addition, the agency is making a number of clarifying minor changes to the regulatory text. In particular, a sentence was added to the test procedures to explicitly specify that non-structural components such as roof racks are removed prior to testing. This was already the agency's interpretation of the current test procedure. The word "accidents" in S2 is replaced with the word "crashes." Figure 1 is revised to
